*Resource Conservation and Recovery Act (RCRA)
Compliance Evaluation Inspection Report*

Total Petroleum Puerto Rico LMM Airport Aviation Terminal

EPA ID Number: PRD980536023
Mailing Address: P.O. Box 362912
San Juan, Puerto Rico, 00936
Physical Address: Base Muñíz
Carolina, Puerto Rico, 00979
Geographical Coordinates: 18°26'30.10"N, 65°59'39.69"W

Inspection Date: April 22, 2016

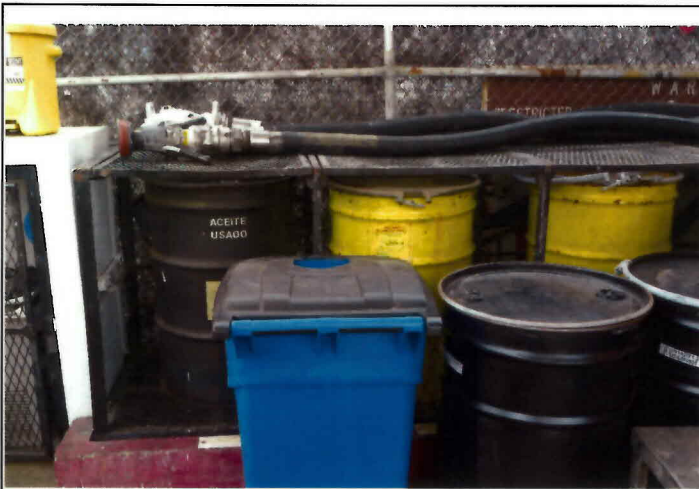
- One (1) 55-gallons container labeled as "Used Oil." At the time of the inspection, this container was ½ full and not dated. In this case, a secondary containment was observed for this container (Picture #1).
- Five (5) 55-gallons containers. At the time of the inspection, these containers were empty. All of them were labeled as hazardous waste and the information available at their label is not from TPPRC, is from ESSO Company (former facility) (Picture #1).
- One (1) 6-gallons container with oily waste (sample test tubes only) (Picture #2). According to Mr. Rodríguez, the samples tubes discarded at this container were used to review if the Total product tested is in good condition. According to the facility representative, a good condition means that the product does not contain and/or were not mixed (or in contact) with water.

Picture 1 — Mechanical Workshop Area— Five (5) 55-gallon containers were empty and the label information was from ESSO Company. Also, One (1) 55-gallon container was observed labeled as used oil.

- The containers observed at this area need to be labeled and dated at all times.
- The spent fluorescents lamps observed at this area need to be stored properly. They need to be inside containers that prevent breakage. Also, the containers need to be labeled and dated at all times. In addition, spent fluorescents lamps need to comply with disposal timeframes.
- The five (5) empty containers. We inquired Mr. Rodriguez and the mechanical technicians about these containers. We asked them why the information presented at the labels are from ESSO Company instead of the information of the current facility (TPPRC). The facility representatives told us that they inherited these containers from the former company and the decision made by the current company was to have them available in case these were needed.

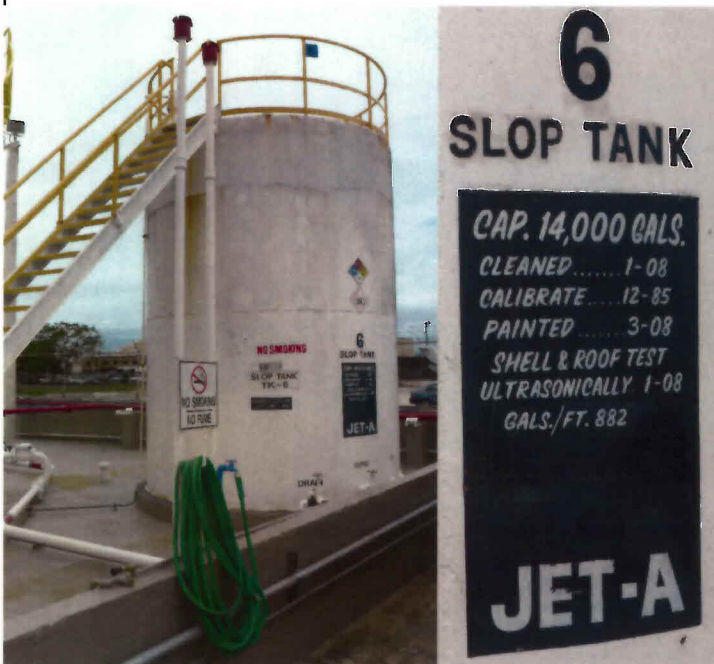
This area was located at right side of the Mechanical Shop Area. At the time of the inspection, a 14,000-gallons tank within a secondary containment was observed (Picture #3). According to the facility representative, this area is also known as the Tank #6 Area. At the time of the inspection, the tank appears to be in good condition; leaks, stains and/or spills were not observed. Furthermore, the facility representative told us that the secondary containment has been treated with epoxy (Picture #4). In addition, according to Mr. Rodríguez, the tank was emptied approximately two (2) weeks ago.

Picture 3 — Slop Tank Area—One (1) 14,000-gallon above-ground tank within a secondary containment was observed.

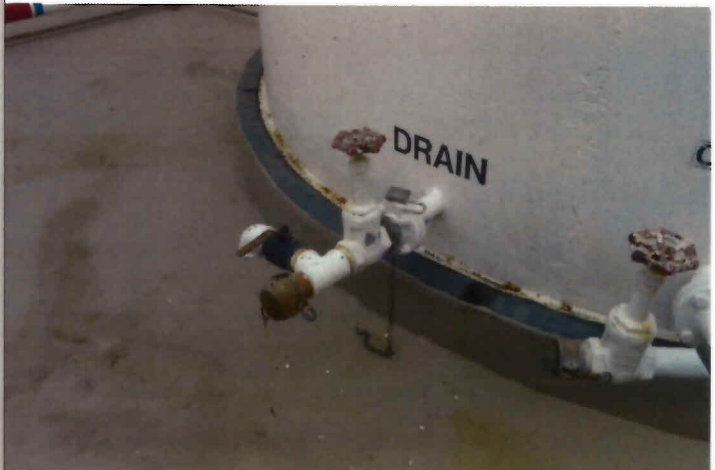
Picture 4 — Slop Tank Area—According to the facility representative, the secondary containment has been treated with epoxy.
